CORRECTED FINAL REPORT

HIGH TEMPERATURE HOT WATER DISTRIBUTION SYSTEM STUDY

**DIRECTORATE OF PUBLIC WORKS
FORT DRUM, NEW YORK**

December 1996

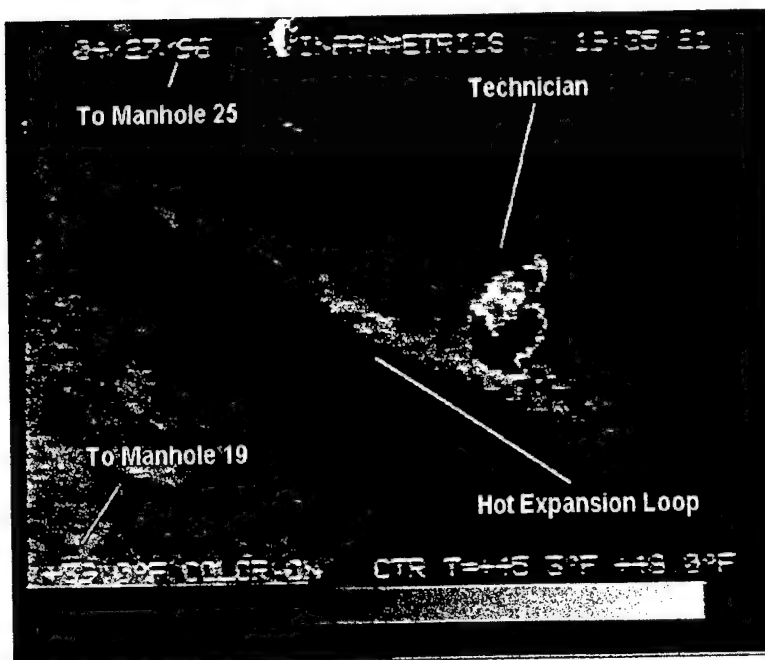
1. Piping from Manhole 19 to Manhole #25 along Second Ave.(16" Sup. Inside a 24" conduit, 16" Ret. Inside a 22" Conduit): The expansion loop area was loosing excessive energy. Two possible causes are: Water in the conduit which has saturated the insulation. Second, the loss of insulation from previous flooding and the action of boiling water. It is not possible to determine if one or both conduits are affected. The balance of the run of pipe appears to be loosing normal levels of energy. The expansion loops may not be laid at the proper angle to allow free flow of the water. This condition will trap water in the expansion loop. The conduit will be subject to corrosion. The insulation may be damaged and boil off the pipe. Recommend excavating the expansion loop and examining the condition of the conduit, pipe and insulation. If the conduit(s) is(are) found to be corroded, the expansion loop(s) can be replaced. Before replacement is considered inspect the conduit for some distance on either side of the "H" legs of the loop to insure the conduit is in weldable condition. The affected sections can be replaced. Once the replacement conduit has been installed an air test will confirm the balance of the conduit is tight.

2. Piping from Manhole #26 to Manhole #27 along Second Ave (16" Sup. Inside a 24" conduit, 16" Ret. Inside a 20" Conduit): Two expansion loops and one spot was noted loosing excessive energy. Two possible causes are: Water in the conduit which has saturated the insulation. Second, the loss of insulation from previous flooding and the action of boiling water. It is not possible to determine if one or both conduits are affected. The balance of the run of pipe appears to be loosing normal levels of energy. The expansion loops may not be laid at the proper angle to allow free flow of the water. This condition will trap water in the expansion loop. The conduit will be subject to internal corrosion. The insulation may be damaged and boil off the pipe. Recommend excavating the expansion loops and examining the condition of the pipe and insulation. Excavate the location along the run of pipe. If the conduit(s) is(are) found to be corroded, the expansion loop can be replaced. Before replacement is considered inspect the conduit for some distance on either side of the "H" legs of the loop to insure the conduit(s) is(are) in weldable condition. The affected section(s) can be replaced. Once the replacement conduit has been installed an air test will confirm the balance of the conduit is tight.

Manhole #19 to Manhole #25
Expansion Loop on MH #25 side.

Manhole #26 to Manhole #27
Expansion Loop on MH #27 side.

Comments: Recommend excavating the expansion loops and examining the condition of the pipe and insulation. Excavate the location along the run of pipe. If the conduit(s) is (are) corroded, the expansion loop can be replaced. before replacement is considered inspect the conduit for some distance on either side of the "H" legs of the loop to insure the conduit(s) is (are) in weldable condition. The affected section(s) can be replaced. Once the replacement conduit has been installed an air test will confirm the balance of the conduit is tight.

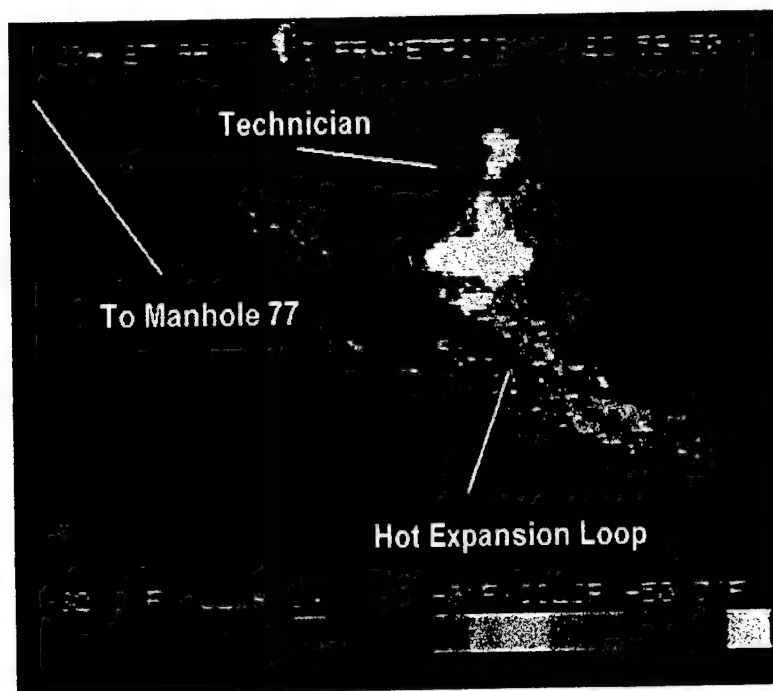
4. Piping from Manhole #77 to Manhole #76 along South Riva Ridge Loop(4" Sup., 4" Ret. Inside an 18" Conduit): The expansion loop area was losing excessive energy. Two possible causes are: Water in the conduit which has saturated the insulation. Second, the loss of insulation from previous flooding and the action of boiling water. It is not possible to determine if one or both conduits are affected. The balance of the run of pipe appears to be losing normal levels of energy. The expansion loops may not be laid at the proper angle to allow free flow of the water. This condition will trap water in the expansion loop. The conduit will be subject to corrosion. The insulation may be damaged and boil off the pipe. Recommend excavating the expansion loop and examining the condition of the conduit, pipe and insulation. If the conduit is found to be corroded, the expansion loop can be replaced. Before replacement is considered inspect the conduit for some distance on either side of the "H" legs of the loop to insure the conduit is in weldable condition. The affected section can be replaced. Once the replacement conduit has been installed an air test will confirm the balance of the conduit is tight.

Manhole #77 to Manhole #76
Expansion Loop on MH #77 side.

Comments: Recommend excavating the expansion loop and examining the condition of the conduit, pipe and insulation. If the conduit is found to be corroded, the expansion loop can be replaced. Before replacement is considered inspect the conduit for some distance on either side of the "H" legs of the loop to insure the conduit is in weldable condition. The affected section can be replaced. Once the replacement conduit has been installed an air test will confirm the balance of the conduit is tight.

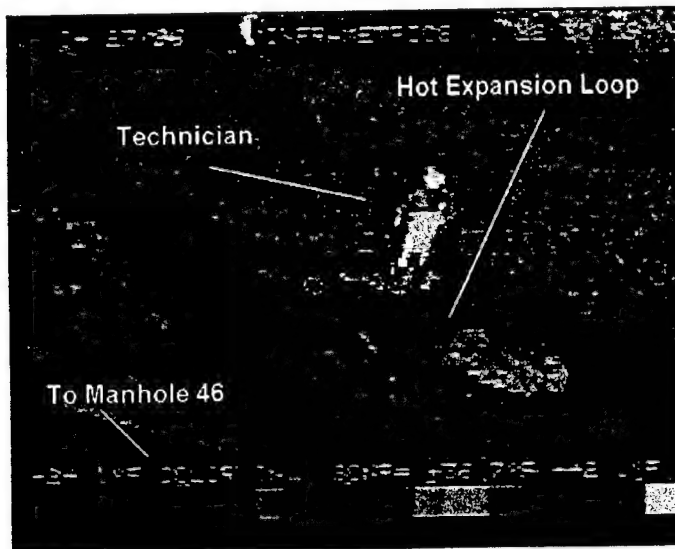
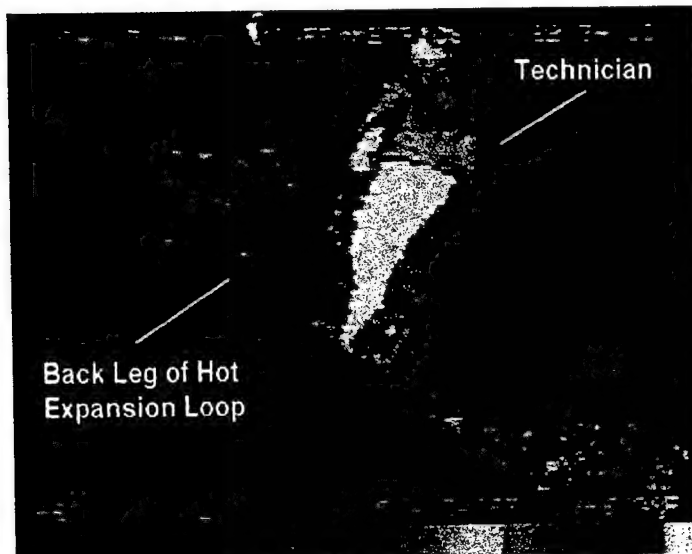
6. Piping from Manhole #46 to Manhole #47 along Fourth Street.(8" Sup. Inside a 16" conduit, 8" Ret. Inside a 14" Conduit): Two expansion loops were noted loosing excessive energy. This problem may have its origin in Manhole #46. The conduit ends may be corroded allowing water from flooding to enter the conduits. The expansion loops may not be laid at the proper angle to allow free flow of the water. The water will stand in the expansion loops. The conduit will be subject to corrosion. The insulation may be damaged and boil off the pipe. Recommend excavating the expansion loops and examining the condition of the conduit, pipe and insulation. If the conduit is found to be corroded, the expansion loop can be replaced. Before replacement is considered inspect the conduit for some distance on either side of the "H" legs of the loop to insure the conduit is in weldable condition. The affected section can be replaced. Once the replacement conduit has been installed an air test will confirm the balance of the conduit is tight.

Manhole #46 to Manhole #47
Expansion Loop on MH #46 side.

Manhole #46 to Manhole #47
Expansion Loop on MH #47 side.

Comments: Recommend excavation the expansion loops and examining the condition of the conduit, pipe and insulation. If the conduit is found to be corroded, the expansion loop can be replaced. Before replacement is considered, inspect the conduit for some distance of either side of the "H" legs of the loop to insure the conduit is in weldable condition. The affected section can be replaced. Once the replacement conduit has been installed an air test will confirm the balance of the conduit is tight.

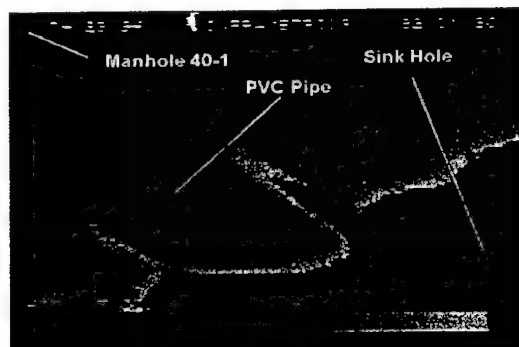
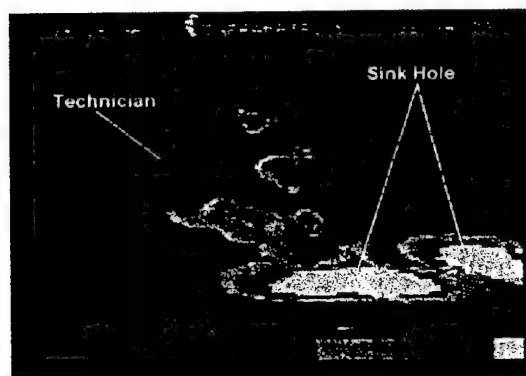
7. Piping from Manhole #40-1 to Manhole #40-2 to Building 1051.(1.5" Sup., 1.5" Ret. Inside a 12" Conduit): The piping between Manhole 40-1 and Manhole 40-2 should be replaced. The condition appears to be beyond economic repair.

Manhole #40-1 to Manhole #40-2
Image #1, Sink Hole

Manhole #40-1 to Manhole #40-2
Image #2, Sink Hole

Manhole #40-1 to Manhole #40-2
Image #3, second sink hole
